ABSTRACT SUBMISSION for**11th Hypervelocity Impact Symposium, Freiburg, Germany
April 11-15, 2010**

James Hyde

**CRATERING EQUATIONS FOR ZINC ORTHOTITANATE COATED
ALUMINUM****Abstract**

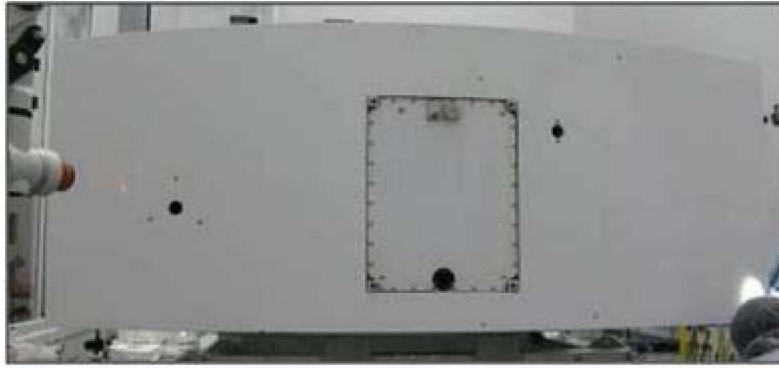
Fig. 1: WFPC2 radiator during post flight inspection.

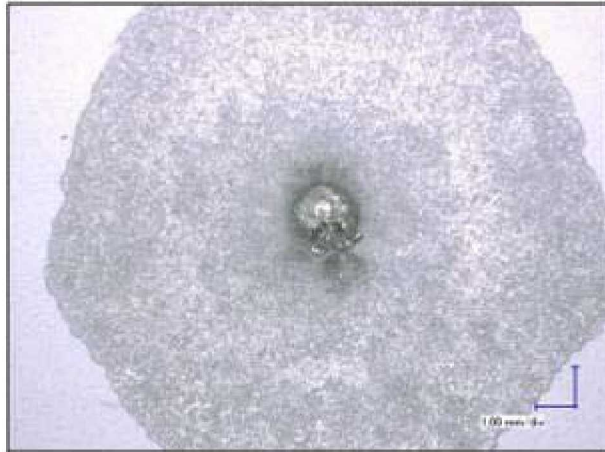
Fig. 2: Impact crater on WFPC2 radiator. Note double crater in center and paint spall . 15 mm spall diameter, 1 mm crater diameter.
